**Flood Control Project Maintenance
Levee Inspections**

Fall 2015 Levee Maintenance Deficiency Summary Report

Sacramento River Basin

Sutter Maintenance Yard East Levee Sacramento River

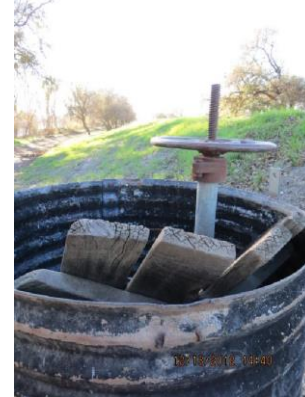
Photo 2 of 3 : UCIP_FA_2015_2825.jpg

Item	DWR UCIP Field Study			39.194106 °	39.194106 °	
				-121.953512 °	-121.953512 °	
DWR ID						
Action/Comments						
Inspector Comments: FS_ID:44135 DS_ID:17319 EP_NO: 9527 FS_HLM: 1.111 Repair Type: Urgent Crossing Status: Found UCIP Comments: 4/6/2015 Pipe leaks during times of High water. Slope damage still present. needs a more detailed inspection to find the leak. Abandoned and plugged/capped steel pipe on WS berm. DWR leaky pipe marker on LS (12-3). Slope failure on LS. Needs capping of LS steel pipe after detailed investigation. 7/29/2013 Pipe does not appear to be abandoned. On the WS it appears that a smaller pipe was sleeved into the 18in. pipe and then the difference capped and welded. Pump was not running at time of inspection but LS ditch near outlet was wet. LS slope damage and leaky pipe marker are still present. 12/30/2013 Same as last inspection. 6/30/2014 Same as last inspection. FIELD_STRUCT_DESC: 18-inch steel pipe through the levee 12.5 feet below the crown. Gate valve on the waterward side. Vertical pump on the bank. (ABO No. 9527 - Butte Creek Farms). O&M manual 136, revision May 2011 FS Date: 04/07/2015

Waterside view: CMP riser with slide gate

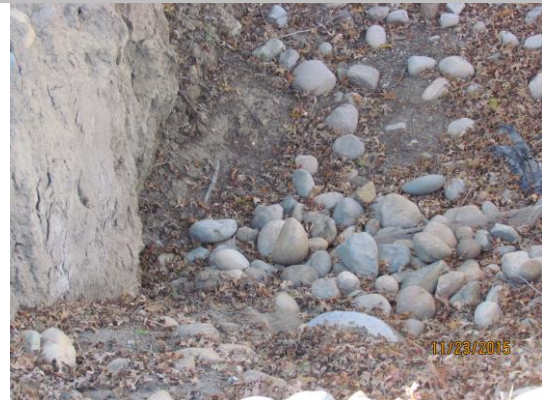
Photo 1 of 1 : FA_2015_ST0003_264_34_20151123_00025.jpg

LM Start	1.18	Rating **	M	Issue No.	34
LM End	1.18	Issue Type +	Ma	Location *	LS
Category	Earthen Levee			GPS Latitude/Longitude	
				Start	End
Item	Erosion / Bank Caving			39.194105 °	39.194105 °
				121.953558 °	121.953558 °
DWR ID	DWR_ST0003_01_s_2013_34				
Action/Comments					
Schedule repair of erosion site prior to the next inspection.					
Inspector Comments: The pipe has rusted apart at the toe of the levee.

View of erosion caused by rusted out pipe on the landside slope.

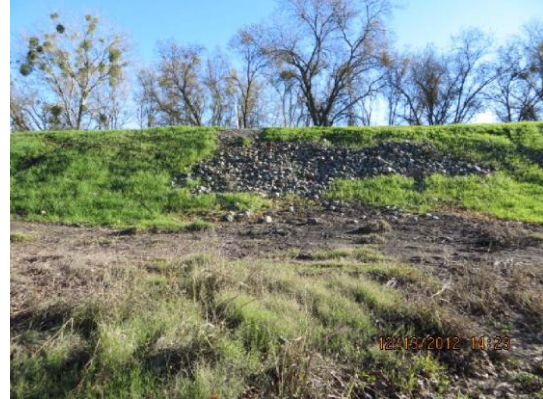
Photo 1 of 3 : UCIP_FA_2015_2827.jpg

LM Start	1.44	Rating **	U	Issue No.	138
LM End	1.44	Issue Type +	En	Location *	LS
Category	Supplemental			GPS Latitude/Longitude	
				Start	End
Item	DWR UCIP Field Study			39.192502 °	39.192502 °
				-121.958062 °	-121.958062 °
DWR ID					
Action/Comments					
Inspector Comments: FS_ID:44136 DS_ID:17320 EP_NO: 9543 FS_HLM: 1.38 Repair Type: Urgent Crossing Status: Found UCIP Comments: 4/6/2015 Pipe leaks during high water. DWR employee said he suspects that the flap gate has rotted and fallen off WS end of pipe. Could not locate WS end of pipe to confirm. Water was flowing through this drain during field survey. 7/29/2013 Same as last inspection. 12/30/2013 Same as last inspection. 6/30/2014 Same as last inspection. FIELD_STRUCT_DESC: 30-inch corrugated metal drainpipe through the levee 25.2 feet below the crown. Flap gate on the waterward end. (ABO No. 9543 -Harada). O&M manual 136, revision May 2011 FS Date: 04/07/2015

Landside view: overview of levee slope

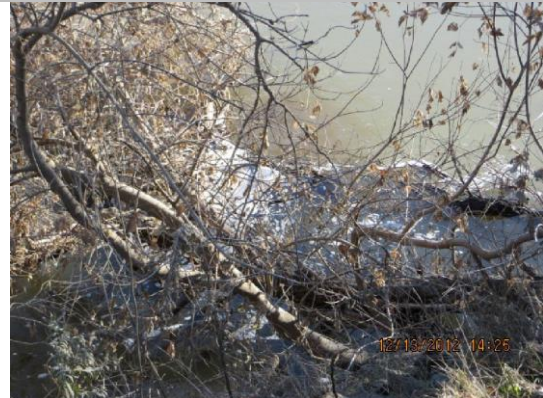
Photo 2 of 3 : UCIP_FA_2015_2828.jpg

Waterside view: water flowing from outlet pipe (pipe fully submerged)

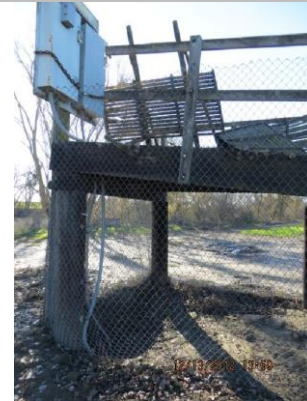
Photo 1 of 3 : UCIP_FA_2015_2830.jpg

LM Start	1.91	Rating **	U	Issue No.	139
LM End	1.91	Issue Type +	En	Location *	LS
Category	Supplemental			GPS Latitude/Longitude	
				Start	End
Item	DWR UCIP Field Study			39.188164 °	39.188164 °
				-121.964721 °	-121.964721 °
DWR ID					
Action/Comments					
Inspector Comments: FS_ID:44138 DS_ID:17321 EP_NO: 9543 FS_HLM: 1.85 Repair Type: Urgent Crossing Status: Found UCIP Comments: 4/6/2015 Sloughing LS slope and river bank. DWR marking for leaky pipe.7/29/2013 Same as last inspection.12/30/2013 Same as last inspection.6/30/2014 Same as last inspection. FIELD_STRUCT_DESC: 14-inch steel pipe encased in concrete through the levee 12.5 feet below the crown. Slant pump mounted on pile structure on berm. Slide gate in 48-inch riser on berm, walkway to pump. Discharges into concrete distribution box at landward toe. Flap gate on the landward end. (ABO No. 9543 - Harada). O&M manual 136, revision May 2011 FS Date: 04/07/2015

Waterside view: abandoned pump station close-up.

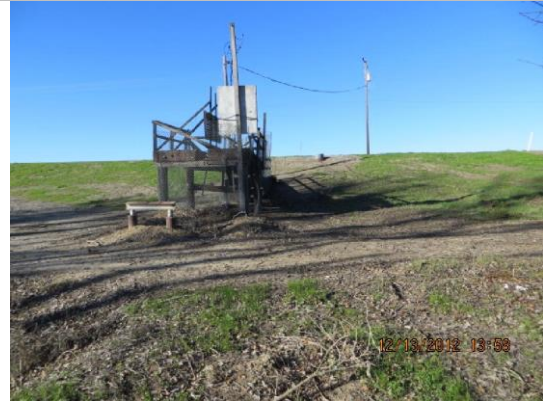
Photo 2 of 3 : UCIP_FA_2015_2831.jpg

Item	DWR UCIP Field Study			39.188164 °	39.188164 °	
				-121.964721 °	-121.964721 °	
DWR ID						
Action/Comments						
Inspector Comments: FS_ID:44138 DS_ID:17321 EP_NO: 9543 FS_HLM: 1.85 Repair Type: Urgent Crossing Status: Found UCIP Comments: 4/6/2015 Sloughing LS slope and river bank. DWR marking for leaky pipe.7/29/2013 Same as last inspection.12/30/2013 Same as last inspection.6/30/2014 Same as last inspection. FIELD_STRUCT_DESC: 14-inch steel pipe encased in concrete through the levee 12.5 feet below the crown. Slant pump mounted on pile structure on berm. Slide gate in 48-inch riser on berm, walkway to pump. Discharges into concrete distribution box at landward toe. Flap gate on the landward end. (ABO No. 9543 - Harada). O&M manual 136, revision May 2011 FS Date: 04/07/2015

Waterside view: abandoned pump station.

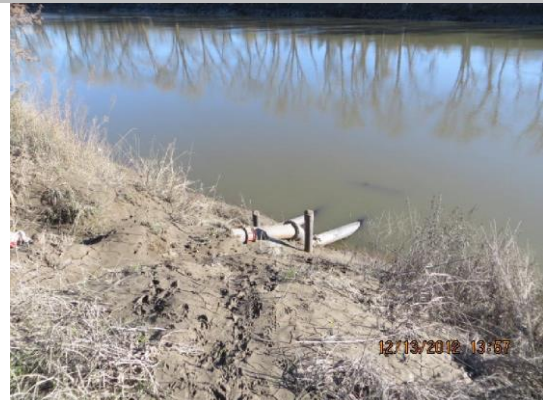
Photo 3 of 3 : UCIP_FA_2015_2832.jpg

Waterside view: pipe @river bank

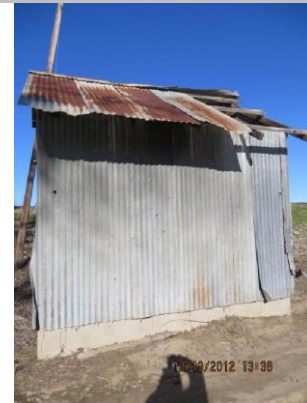
Photo 2 of 3 : UCIP_FA_2015_2834.jpg

LM Start	2.08	Rating **	M	Issue No.	140
LM End	2.08	Issue Type +	En	Location *	LS
Category	Supplemental			GPS Latitude/Longitude	
				Start	End
Item	DWR UCIP Field Study			39.187717 °	39.187717 °
				-121.967712 °	-121.967712 °
DWR ID					
Action/Comments					
Inspector Comments: FS_ID:44139					
DS_ID:17305					
EP_NO: 9541					
FS_HLM: 2.016					
Repair Type: Non-Urgent					
Crossing Status: Found

Waterside view: abandoned pump house

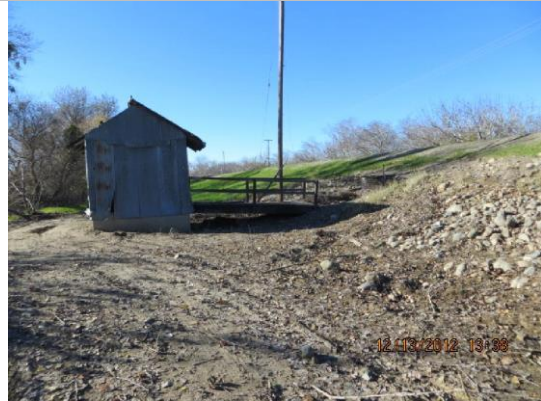
Photo 3 of 3 : UCIP_FA_2015_2835.jpg

LM Start	2.08	Rating **	M	Issue No.	140 (cont)
LM End	2.08	Issue Type +	En	Location *	LS
Category	Supplemental			GPS Latitude/Longitude	
				Start	End
Item	DWR UCIP Field Study			39.187717 °	39.187717 °
				-121.967712 °	-121.967712 °
DWR ID					
Action/Comments					
Inspector Comments: FS_ID:44139					
DS_ID:17305					
EP_NO: 9541					
FS_HLM: 2.016					
Repair Type: Non-Urgent					
Crossing Status: Found

Waterside view: overview

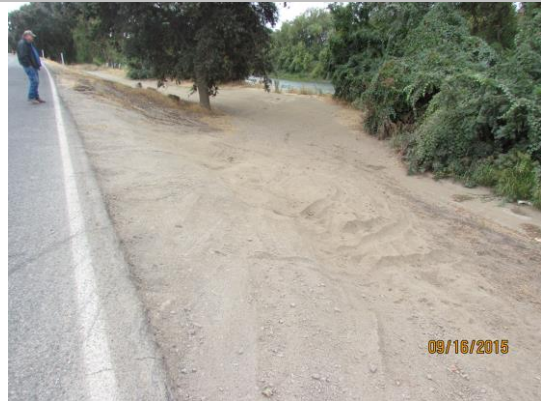
Photo 1 of 1 : FA_2015_ST0003_264_51_20151013_00022.jpg

LM Start	2.83	Rating **	M	Issue No.	51
LM End	2.83	Issue Type +	Ma	Location *	WS
Category	Earthen Levee			GPS Latitude/Longitude	
				Start	End
Item	Slope Stability			39.191158 °	39.191158 °
				-121.980278 °	-121.980278 °
DWR ID	DWR_ST0003_01_f _ 2015_51				
Action/Comments					
Repair the levee slope damaged by vehicle traffic and prevent access where possible.					
Inspector Comments: Repair the erosion along the waterside slope.

View of the vehicle erosion along the waterside slope.

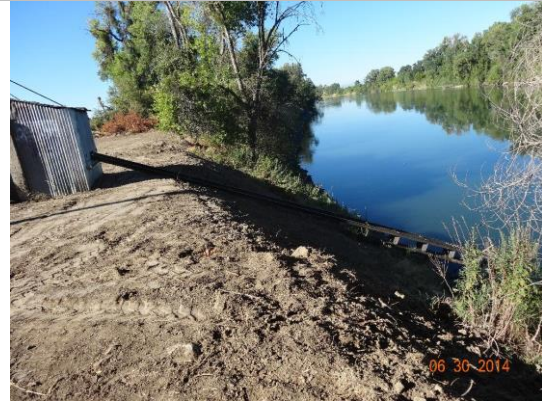
Photo 3 of 3 : UCIP_FA_2015_6635.jpg

UCIP Comments: 4/6/2015 Same as last inspection. Concrete pit on WS berm. Concrete distribution box on LS silted and erosion around the box. Slope failure/ transverse cracks on LS levee slope. Two depressions on WS berm. 7/29/2013 Repairs to LS slope and pipe are in progress. Nothing has been done yet to the WS depressions. 12/30/2013 Repairs to LS and WS slopes have been completed. Not sure if this is an active or abandoned crossing. LS distribution box is still silted in. 6/30/2014 Crossing appears to be being made active again. WS bank has been cleared of all vegetation and debris to allow pump to slide down to water level. New shutoff valve installed on WS shoulder inside of cmp stand pipe. New air-vac installed inside cmp standpipe on LS shoulder and air vent installed on LS toe. Could not locate pipe end on LS. Need to check for permit number for work done.

WS river bank

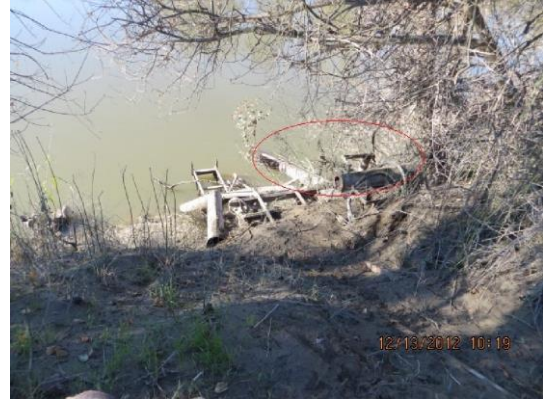
Photo 1 of 3 : UCIP_FA_2015_2674.jpg

LM Start	4.44	Rating **	U	Issue No.	144
LM End	4.44	Issue Type +	En	Location *	WS
Category	Supplemental			GPS Latitude/Longitude	
				Start	End
Item	DWR UCIP Field Study			39.210257 °	39.210257 °
				-121.988250 °	-121.988250 °
DWR ID					
Action/Comments					
Inspector Comments: FS_ID:44175 DS_ID:17326 EP_NO: 9501 FS_HLM: 4.383 Repair Type: Urgent Crossing Status: Found UCIP Comments: 4/6/2015 Same as last inspection.Need to be properly abandoned. Transverse cracks on levee road.Also found a concrete outlet on LS. It is not clear whether this passes through the levee.7/29/2013 Same as last inspection.12/30/2013 Same as last inspection.6/30/2014 Same as last inspection. FIELD_STRUCT_DESC: Abandoned 16-inch steel pipe through the levee 13.9 feet below the crown. Gate valve and pump in pump house on berm. Flap gate and concrete distribution box on the landward end. (ABO No. 9501 - Mayfair Farms). O&M manual 136, revision May 2011. FS Date: 04/07/2015

Waterside view: overview of pipe

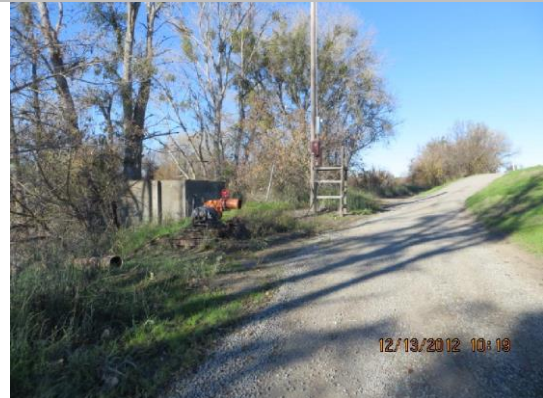
Photo 2 of 3 : UCIP_FA_2015_2675.jpg

Waterside view: overview

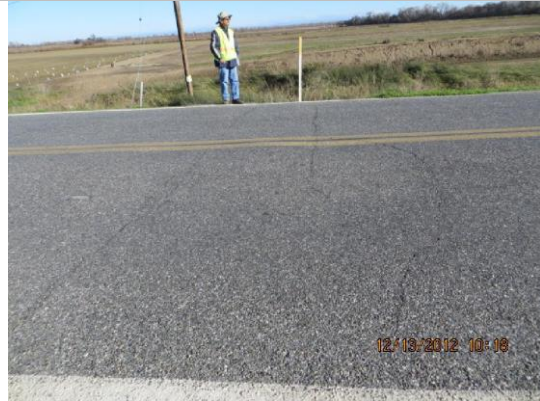
Photo 3 of 3 : UCIP_FA_2015_2676.jpg

LM Start	4.44	Rating **	U	Issue No.	144 (cont)
LM End	4.44	Issue Type +	En	Location *	WS
Category	Supplemental			GPS Latitude/Longitude	
				Start	End
Item	DWR UCIP Field Study			39.210257 °	39.210257 °
				-121.988250 °	-121.988250 °
DWR ID					
Action/Comments					
Inspector Comments: FS_ID:44175					
DS_ID:17326					
EP_NO: 9501					
FS_HLM: 4.383					
Repair Type: Urgent					
Crossing Status: Found

Crown view: cracks along pipe alignment (transverse crack)

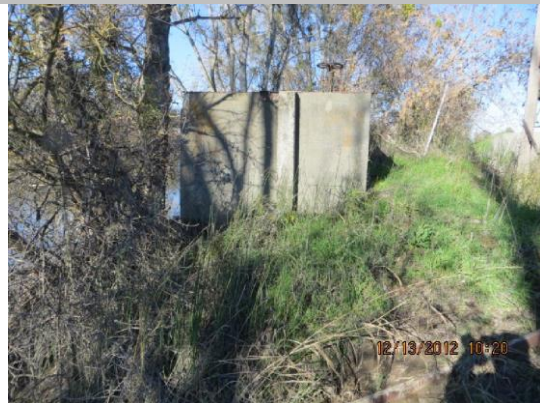
Photo 1 of 3 : UCIP_FA_2015_2677.jpg

LM Start	4.44	Rating **	U	Issue No.	145
LM End	4.44	Issue Type +	En	Location *	WS
Category	Supplemental			GPS Latitude/Longitude	
				Start	End
Item	DWR UCIP Field Study			39.210280 °	39.210280 °
				-121.988284 °	-121.988284 °
DWR ID					
Action/Comments					
Inspector Comments: FS_ID:44176					
DS_ID:17484					
EP_NO: N/A					
FS_HLM: 4.385					
Repair Type: Urgent					
Crossing Status: Found					
UCIP Comments: 4/6/2015 Crossing appears to be an old irrigation structure and not a drain pipe. it appears abandoned as WS surge box is full of debris. Debris and deteriorated concrete. Gate valve in surge tank. 7/29/2013 Same as last inspection. 12/30/2013 Same as last inspection. 6/30/2014 Same as last inspection.					
FIELD_STRUCT_DESC: 24 inch pipe, 26 ft invert below crown, Slide Gate ws. O&M manual 136, revision May 2011.					
FS Date: 04/07/2015

Waterside view: concrete surge box

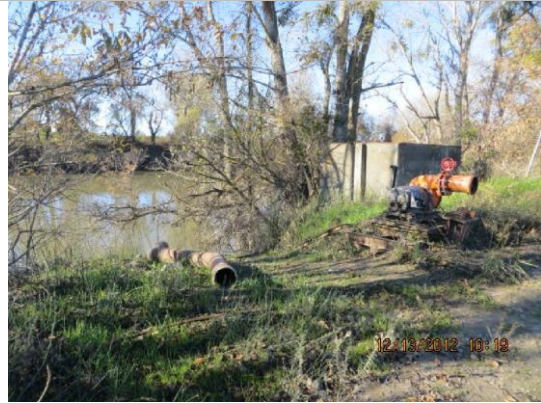
Photo 2 of 3 : UCIP_FA_2015_2678.jpg

Inspector Comments: FS_ID:44176
 DS_ID:17484
 EP_NO: N/A
 FS_HLM: 4.385
 Repair Type: Urgent
 Crossing Status: Found
 UCIP Comments: 4/6/2015 Crossing appears to be an old irrigation structure and not a drain pipe. it appears abandoned as WS surge box is full of debris. Debris and deteriorated concrete. Gate valve in surge tank. 7/29/2013 Same as last inspection. 12/30/2013 Same as last inspection. 6/30/2014 Same as last inspection.
 FIELD_STRUCT_DESC: 24 inch pipe, 26 ft invert below crown, Slide Gate ws. O&M manual 136, revision May 2011.
 FS Date: 04/07/2015

Waterside view: overview of concrete surge box

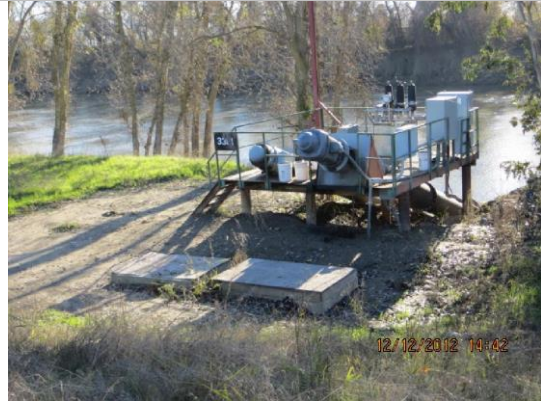
Photo 1 of 2 : UCIP_FA_2015_2680.jpg

LM Start	4.64	Rating **	U	Issue No.	146
LM End	4.64	Issue Type +	En	Location *	WS
Category	Supplemental			GPS Latitude/Longitude	
				Start	End
Item	DWR UCIP Field Study			39.212627 °	39.212627 °
				-121.990413 °	-121.990413 °
DWR ID					
Action/Comments					
Inspector Comments: FS_ID:44177					
DS_ID:17318					
EP_NO: 10935					
FS_HLM: 4.586					
Repair Type: Urgent					
Crossing Status: Found

Waterside view: overview of pump station

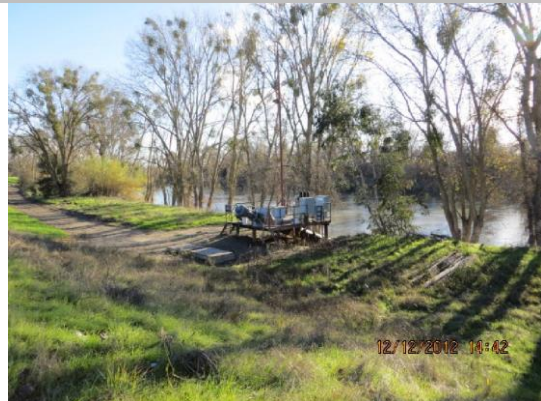
Photo 2 of 2 : UCIP_FA_2015_2681.jpg

Waterside view: overview

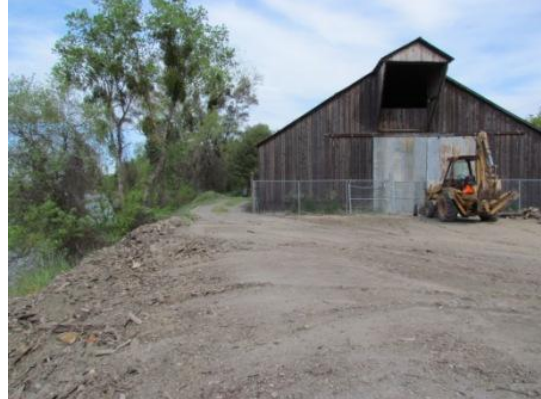
Photo 1 of 1 : FA_2015_ST0003_264_12_20150910_00004.jpg

LM Start	4.72	Rating **	U	Issue No.	12
LM End	4.72	Issue Type +	En	Location *	CR
Category	Earthen Levee			GPS Latitude/Longitude	
				Start	End
Item	Encroachments			39.213265 °	39.213265 °
				-121.991672 °	-121.991672 °
DWR ID	DWR_ST0003_01_s_2012_12				
Action/Comments					
Building

View of the barn on the large crown of the levee.

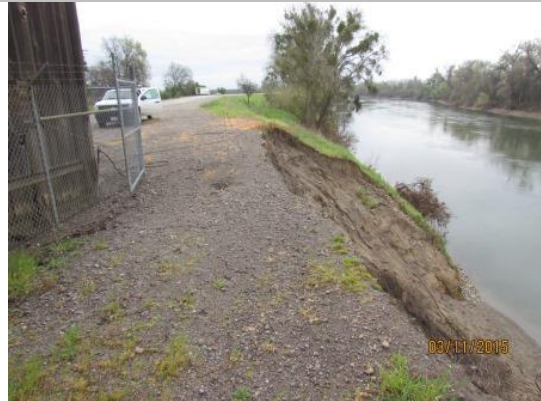
Photo 1 of 1 : FA_2015_ST0003_264_15_20150910_00006.jpg

LM Start	4.72	Rating **	U	Issue No.	15
LM End	4.72	Issue Type +	Ma	Location *	WS
Category	Earthen Levee			GPS Latitude/Longitude	
				Start	End
Item	Erosion / Bank Caving			39.213271 °	39.213271 °
				-121.991676 °	-121.991676 °
DWR ID	DWR_ST0003_01_s_2013_15				
Action/Comments					
Schedule repair of erosion site prior to the next inspection.					
Inspector Comments: The erosion needs to be repaired.

View of the erosion along the waterside slope.

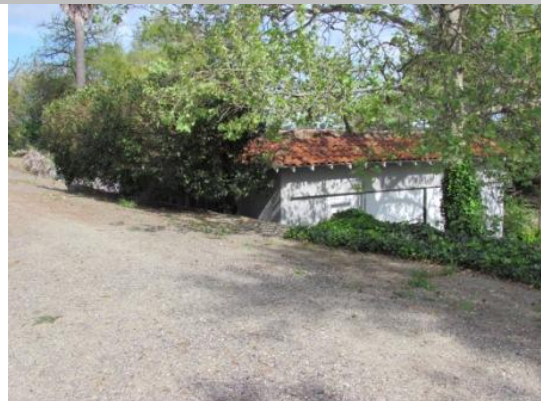
Photo 1 of 1 : FA_2015_ST0003_264_20_20150910_00008.jpg

LM Start	4.84	Rating **	U	Issue No.	20
LM End	4.84	Issue Type +	En	Location *	LS
Category	Earthen Levee			GPS Latitude/Longitude	
				Start	End
Item	Encroachments			39.214168 °	39.214168 °
				-121.993515 °	-121.993515 °
DWR ID	DWR_ST0003_01_s_2012_20				
Action/Comments					
Building

View of the building next to the L/S toe.

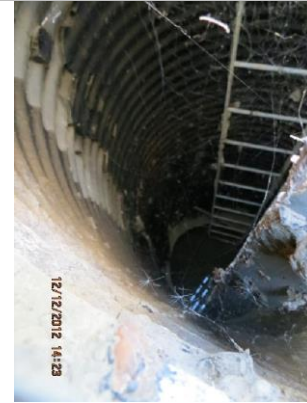
Photo 1 of 3 : UCIP_FA_2015_2682.jpg

LM Start	5.03	Rating **	M	Issue No.	147 (cont)
LM End	5.03	Issue Type +	En	Location *	WS

Waterside view: inside CMP riser

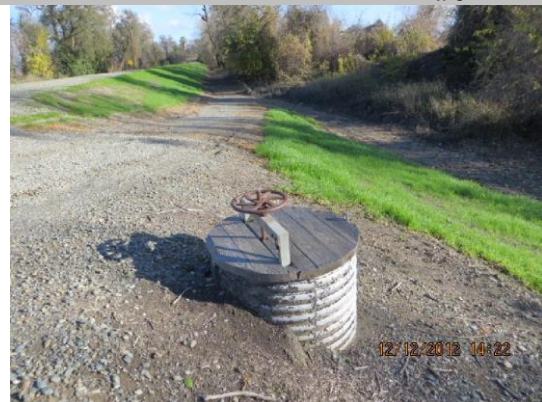
Photo 2 of 3 : UCIP_FA_2015_2683.jpg

Waterside view: CMP riser with slide gate

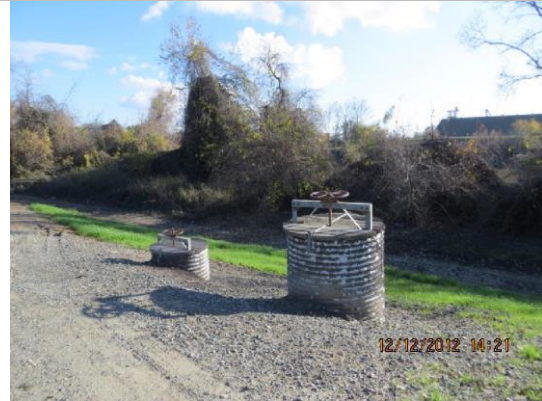
Photo 3 of 3 : UCIP_FA_2015_2684.jpg

LM Start	5.03	Rating **	M	Issue No.	147 (cont)
LM End	5.03	Issue Type +	En	Location *	WS
Category	Supplemental			GPS Latitude/Longitude	
				Start	End
Item	DWR UCIP Field Study			39.214949 °	39.214949 °
				-121.996980 °	-121.996980 °
DWR ID					
Action/Comments					
Inspector Comments: FS_ID:44179					
DS_ID:17287					
EP_NO: 9520					
FS_HLM: 4.978					
Repair Type: Non-Urgent					
Crossing Status: Indicator Found

Waterside view: overview

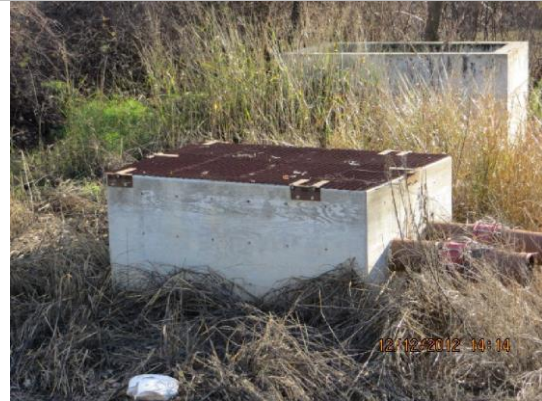
Photo 2 of 3 : UCIP_FA_2015_2843.jpg

UCIP Comments: 4/6/2015 Repairs are in progress to this crossing. Surge box on WS and distribution box across the county road on LS. Abandoned pump station and electrical panel on WS. A concrete pump pit on WS. 7/29/2013 Portable tow-pump lowered down WS berm to water level and is pumping water into concrete surge box on WS and the filling the irrigation ditch on LS. Sink hole with standing water that is present above the outlet pipe for the WS surge box. This may indicate a leaking pipe or cracked concrete. 12/30/2013 Sink Hole above pipe on WS still present. Pipe end inside of WS surge box shows heavy signs of rust and corrosion. Recommend having an internal camera inspection completed on pipe. 6/30/2014 Sink hole near WS surge box is still present. Portable pumps were lowered down the WS bank and were pumping water directly into WS standpipe on to by pass the surge box. FIELD_STRUCT_DESC: 36-inch corrugated metal pipe through the levee 18.4 feet below the crown. Slide gate in corrugate metal pipe riser on waterward shoulder, pump and concrete pump pit on the waterward bank. Concrete surge box on the waterward berm. Discharges into irrigation ditch on the opposite side of the county road. (App. No. 2904 - Arnold). Application was for an existing pumping system. O&M manual 136, revision May 2011. FS Date: 04/07/2015

Waterside view: closer look at surge box

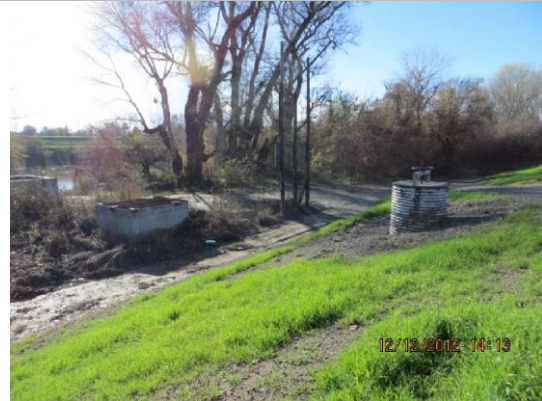
Photo 3 of 3 : UCIP_FA_2015_2844.jpg

UCIP Comments: 4/6/2015 Repairs are in progress to this crossing. Surge box on WS and distribution box across the county road on LS. Abandoned pump station and electrical panel on WS. A concrete pump pit on WS. 7/29/2013 Portable tow-pump lowered down WS berm to water level and is pumping water into concrete surge box on WS and the filling the irrigation ditch on LS. Sink hole with standing water that is present above the outlet pipe for the WS surge box. This may indicate a leaking pipe or cracked concrete. 12/30/2013 Sink Hole above pipe on WS still present. Pipe end inside of WS surge box shows heavy signs of rust and corrosion. Recommend having an internal camera inspection completed on pipe. 6/30/2014 Sink hole near WS surge box is still present. Portable pumps were lowered down the WS bank and were pumping water directly into WS standpipe on to by pass the surge box. FIELD_STRUCT_DESC: 36-inch corrugated metal pipe through the levee 18.4 feet below the crown. Slide gate in corrugate metal pipe riser on waterward shoulder, pump and concrete pump pit on the waterward bank. Concrete surge box on the waterward berm. Discharges into irrigation ditch on the opposite side of the county road. (App. No. 2904 - Arnold). Application was for an existing pumping system. O&M manual 136, revision May 2011. FS Date: 04/07/2015

Waterside view: overview

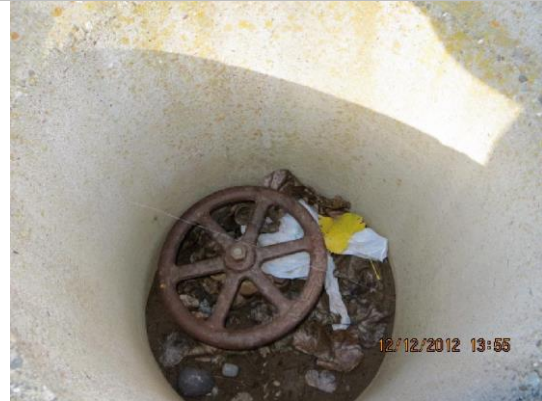
Photo 1 of 2 : UCIP_FA_2015_2845.jpg

Inspector Comments: FS_ID:44187
 DS_ID:17291
 EP_NO: 4091
 FS_HLM: 5.095
 Repair Type: Non-Urgent
 Crossing Status: Found
 UCIP Comments: 4/6/2015 Same as last inspection. Crossing appears abandoned. Appears abandoned and if so should be done so properly. No Siphon breaker found on LS. 7/29/2013 Same as last inspection. 12/30/2013 Same as last inspection. 6/30/2014 Same as last inspection.
 FIELD_STRUCT_DESC: Abandoned 8-inch steel pipe through the levee 4.0 feet below the crown. Pump on bank. Gate valve in concrete pipe riser on waterward shoulder. (App. No. 4091 - Halsey).
 FS Date: 04/07/2015

LM Start	5.15	Rating **	M	Issue No.	149 (cont)
LM End	5.15	Issue Type +	En	Location *	WS

Waterside view: buried gate valve in concrete pipe riser

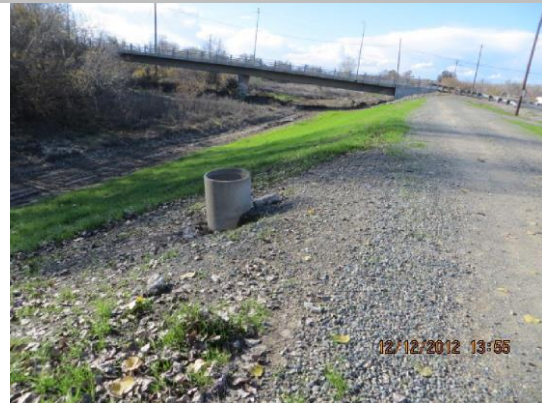
Photo 2 of 2 : UCIP_FA_2015_2846.jpg

Waterside view: concrete pipe riser with gate valve

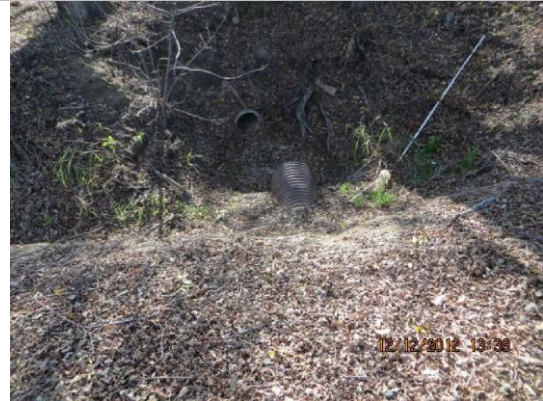
Photo 1 of 3 : UCIP_FA_2015_2847.jpg

LM Start	5.43	Rating **	U	Issue No.	150
LM End	5.43	Issue Type +	En	Location *	WS
Category	Supplemental			GPS Latitude/Longitude	
				Start	End
Item	DWR UCIP Field Study			39.217099 °	39.217099 °
				-122.003778 °	-122.003778 °
DWR ID					
Action/Comments					
Inspector Comments: FS_ID:44207					
DS_ID:17293					
EP_NO: 9514					
FS_HLM: 5.378					
Repair Type: Urgent					
Crossing Status: Found

Waterside view: water transfer ditch

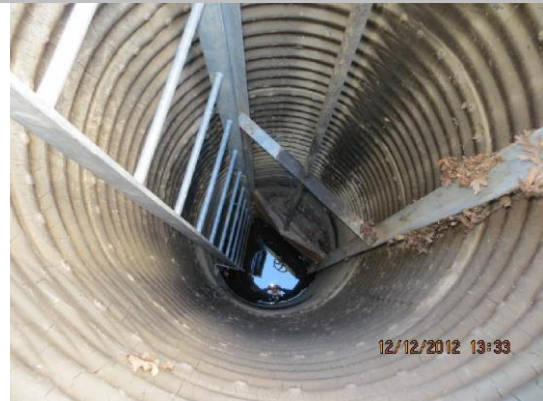
Photo 2 of 3 : UCIP_FA_2015_2854.jpg

Waterside view: inside CMP riser

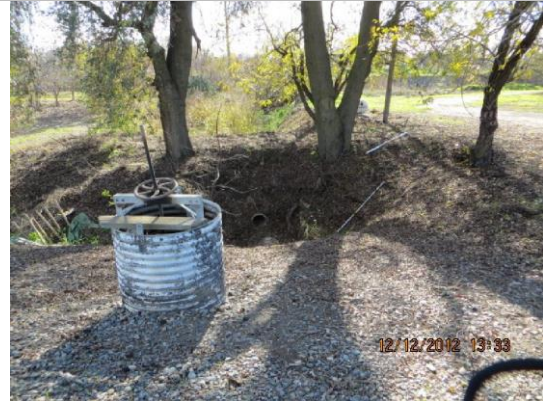
Photo 3 of 3 : UCIP_FA_2015_2855.jpg

LM Start	5.43	Rating **	U	Issue No.	150 (cont)
LM End	5.43	Issue Type +	En	Location *	WS
Category	Supplemental			GPS Latitude/Longitude	
				Start	End
Item	DWR UCIP Field Study			39.217099 °	39.217099 °
				-122.003778 °	-122.003778 °
DWR ID					
Action/Comments					
Inspector Comments: FS_ID:44207					
DS_ID:17293					
EP_NO: 9514					
FS_HLM: 5.378					
Repair Type: Urgent					
Crossing Status: Found

Waterside view: CMP riser with slide gate

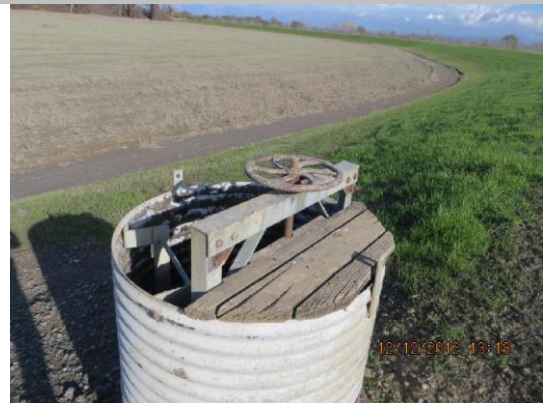
Photo 1 of 3 : UCIP_FA_2015_2891.jpg

LM Start	6.08	Rating **	U	Issue No.	151
LM End	6.08	Issue Type +	En	Location *	WS
Category	Supplemental			GPS Latitude/Longitude	
				Start	End
Item	DWR UCIP Field Study			39.220701 °	39.220701 °
				-122.002538 °	-122.002538 °
DWR ID					
Action/Comments					
Inspector Comments: FS_ID:44208 DS_ID:17294 EP_NO: 9514 FS_HLM: 6.02 Repair Type: Urgent Crossing Status: Found UCIP Comments: 4/1/2015 PVC pipe still runs through crossing. WS end has been covered and blocked with sandbags to prevent water flow during high water season.36-inch CMP found instead of 30-inch CMP. LS pipe tampered.7/23/2013 8inch PVC pipe ran through 36inch CMP preventing screw gate from closing for high water season.12/18/2013 Same as last inspection. Levee inspections is working with land owner to solve the issue.6/30/2014 Same as last inspection. FIELD_STRUCT_DESC: 36-inch corrugated metal drainpipe through the levee 12.0 feet below the crown. Slide gate in corrugated metal pipe riser on the waterward slope. (ABO No. 9514 - Boggs). O&M manual 136, revision May 2011. FS Date: 04/07/2015

Waterside view: CMP riser with slide gate

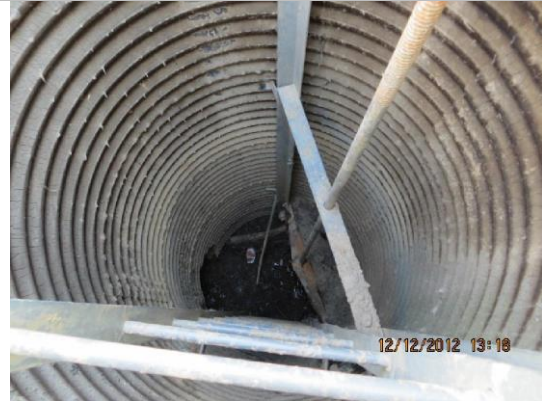
Photo 2 of 3 : UCIP_FA_2015_2892.jpg

Action/Comments					
Inspector Comments: FS_ID:44208 DS_ID:17294 EP_NO: 9514 FS_HLM: 6.02 Repair Type: Urgent Crossing Status: Found UCIP Comments: 4/1/2015 PVC pipe still runs through crossing. WS end has been covered and blocked with sandbags to prevent water flow during high water season. 36-inch CMP found instead of 30-inch CMP. LS pipe tampered. 7/23/2013 8inch PVC pipe ran through 36inch CMP preventing screw gate from closing for high water season. 12/18/2013 Same as last inspection. Levee inspections is working with land owner to solve the issue. 6/30/2014 Same as last inspection. FIELD_STRUCT_DESC: 36-inch corrugated metal drainpipe through the levee 12.0 feet below the crown. Slide gate in corrugated metal pipe riser on the waterward slope. (ABO No. 9514 - Boggs). O&M manual 136, revision May 2011. FS Date: 04/07/2015

Waterside view: inside CMP riser

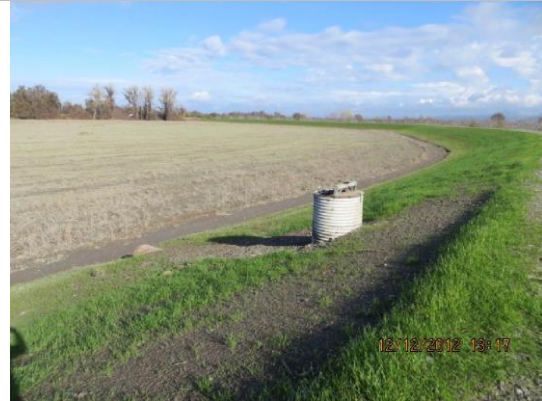
Photo 3 of 3 : UCIP_FA_2015_2893.jpg

LM Start	6.08	Rating **	U	Issue No.	151 (cont)
LM End	6.08	Issue Type +	En	Location *	WS
Category	Supplemental			GPS Latitude/Longitude	
				Start	End
Item	DWR UCIP Field Study			39.220701 °	39.220701 °
				-122.002538 °	-122.002538 °
DWR ID					
Action/Comments					
Inspector Comments: FS_ID:44208 DS_ID:17294 EP_NO: 9514 FS_HLM: 6.02 Repair Type: Urgent Crossing Status: Found UCIP Comments: 4/1/2015 PVC pipe still runs through crossing. WS end has been covered and blocked with sandbags to prevent water flow during high water season.36-inch CMP found instead of 30-inch CMP. LS pipe tampered.7/23/2013 8inch PVC pipe ran through 36inch CMP preventing screw gate from closing for high water season.12/18/2013 Same as last inspection. Levee inspections is working with land owner to solve the issue.6/30/2014 Same as last inspection. FIELD_STRUCT_DESC: 36-inch corrugated metal drainpipe through the levee 12.0 feet below the crown. Slide gate in corrugated metal pipe riser on the waterward slope. (ABO No. 9514 - Boggs). O&M manual 136, revision May 2011. FS Date: 04/07/2015

Waterside view: overview

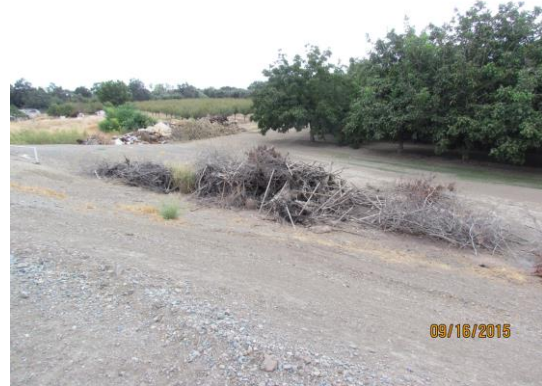
Photo 2 of 2 : FA_2015_ST0003_264_53_20151013_00023.jpg

LM Start	6.38	Rating **	M	Issue No.	53 (cont)
LM End	6.38	Issue Type +	En	Location *	LS
Category	Earthen Levee			GPS Latitude/Longitude	
				Start	End
Item	Encroachments			39.223563 °	39.223563
				-121.999048 °	-121.999048
DWR ID	DWR_ST0003_01_s_2014_53				
Action/Comments					
Prunings					
Inspector Comments: Remove the prunings from the landside toe.

View of the prunings along landside toe.

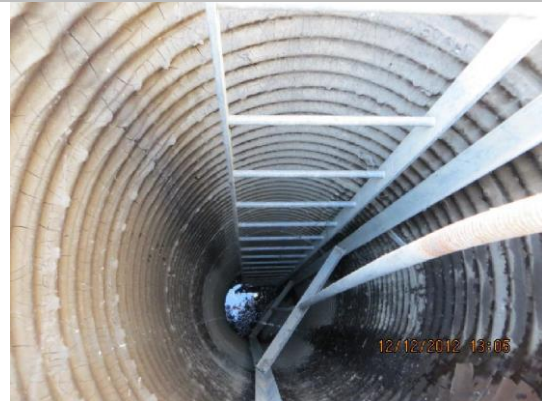
Photo 1 of 3 : UCIP_FA_2015_2894.jpg

LM Start	6.40	Rating **	M	Issue No.	152
LM End	6.40	Issue Type +	En	Location *	LS
Category	Supplemental			GPS Latitude/Longitude	
				Start	End
Item	DWR UCIP Field Study			39.223796 °	39.223796 °
				-121.999014 °	-121.999014 °
DWR ID					
Action/Comments					
Inspector Comments: FS_ID:44209 DS_ID:17306 EP_NO: 9530 FS_HLM: 6.344 Repair Type: Non-Urgent Crossing Status: Found UCIP Comments: 4/1/2015 WS pipe end 3/4 blocked by soil. LS end is still unknown.Pipe outlet on WS partially buried, it needs cleaning.7/23/2013 Same as last inspection12/18/2013 Same as last inspection.6/30/2014 Same as last inspection. FIELD_STRUCT_DESC: 30-inch corrugated metal drainpipe through the levee 15.0 feet below the crown. Slide gate in corrugated metal pipe riser on the waterward slope. (ABO No. 9530 - Halsey). FS Date: 04/07/2015

Waterside view: inside CMP riser

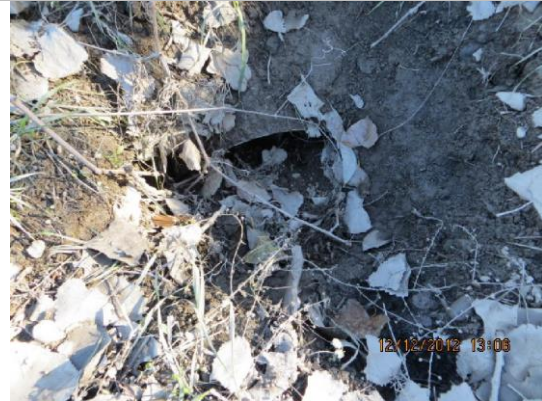
Photo 2 of 3 : UCIP_FA_2015_2895.jpg

Inspector Comments: FS_ID:44209
 DS_ID:17306
 EP_NO: 9530
 FS_HLM: 6.344
 Repair Type: Non-Urgent
 Crossing Status: Found
 UCIP Comments: 4/1/2015 WS pipe end 3/4 blocked by soil. LS end is still unknown. Pipe outlet on WS partially buried, it needs cleaning. 7/23/2013 Same as last inspection 12/18/2013 Same as last inspection. 6/30/2014 Same as last inspection.
 FIELD_STRUCT_DESC: 30-inch corrugated metal drainpipe through the levee 15.0 feet below the crown. Slide gate in corrugated metal pipe riser on the waterward slope. (ABO No. 9530 - Halsey).
 FS Date: 04/07/2015

Waterside view: partially buried steel pipe

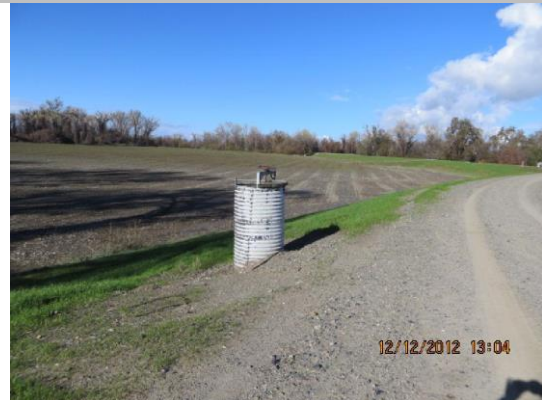
Photo 3 of 3 : UCIP_FA_2015_2896.jpg

Waterside view: CMP riser with slide gate

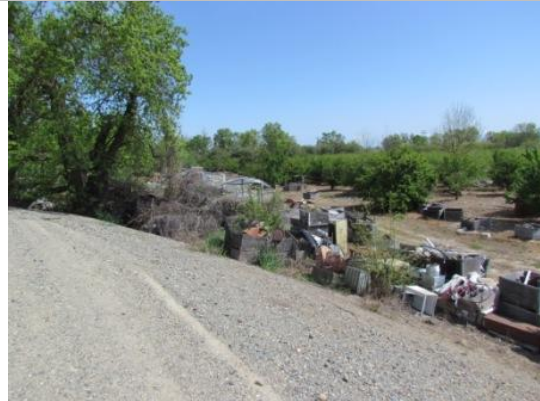
Photo 1 of 1 : FA_2015_ST0003_264_21_20150910_00009.jpg

LM Start	6.48	Rating **	M	Issue No.	21
LM End	6.49	Issue Type +	En	Location *	LS
Category	Earthen Levee			GPS Latitude/Longitude	
				Start	End
Item	Encroachments			39.224982 °	39.225013 °
				-121.998600 °	-121.998585 °
DWR ID	DWR_ST0003_01_s_2012_21				
Action/Comments					
Material

View of the material & garbage along the toe.

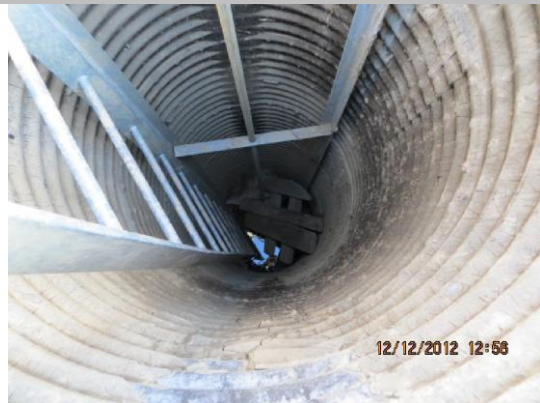
Photo 1 of 2 : UCIP_FA_2015_2897.jpg

LM Start	6.64	Rating **	M	Issue No.	153
LM End	6.64	Issue Type +	En	Location *	LS
Category	Supplemental			GPS Latitude/Longitude	
				Start	End
Item	DWR UCIP Field Study			39.226991 °	39.226991 °
				-121.999907 °	-121.999907 °
DWR ID					
Action/Comments					
Inspector Comments: FS_ID:44211 DS_ID:17296 EP_NO: 9530 FS_HLM: 6.584 Repair Type: Non-Urgent Crossing Status: Found UCIP Comments: 4/1/2015 Only cmp riser with screwgate found on WS. Screwgate stem is bent. Appears abandoned and should be verified as having been done so properly. Only CMP riser with slide gate found on WS7/23/2013 Same as last inspection12/18/2013 Same as last inspection.6/30/2014 Same as last inspection. FIELD_STRUCT_DESC: 24-inch corrugated metal drainpipe through the levee 13.5 feet below the crown. Slide gate in corrugated metal pipe riser on waterward slope. (ABO No. 9530 - Halsey). O&M manual 136, revision May 2011. FS Date: 04/07/2015

Waterside view: inside CMP riser

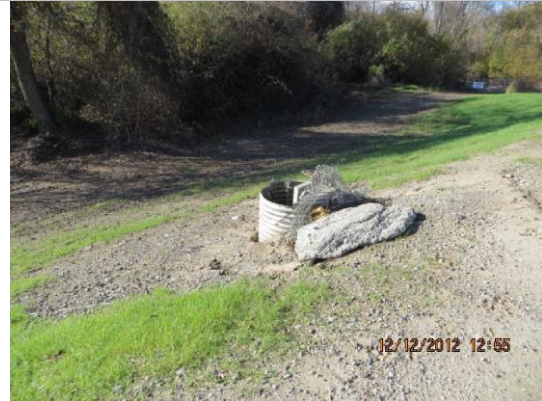
Photo 2 of 2 : UCIP_FA_2015_2898.jpg

LM Start	6.64	Rating **	M	Issue No.	153 (cont)
LM End	6.64	Issue Type +	En	Location *	LS
Category	Supplemental			GPS Latitude/Longitude	
				Start	End
Item	DWR UCIP Field Study			39.226991 °	39.226991 °
				-121.999907 °	-121.999907 °
DWR ID					
Action/Comments					
Inspector Comments: FS_ID:44211 DS_ID:17296 EP_NO: 9530 FS_HLM: 6.584 Repair Type: Non-Urgent Crossing Status: Found UCIP Comments: 4/1/2015 Only cmp riser with screwgate found on WS. Screwgate stem is bent. Appears abandoned and should be verified as having been done so properly. Only CMP riser with slide gate found on WS7/23/2013 Same as last inspection12/18/2013 Same as last inspection.6/30/2014 Same as last inspection. FIELD_STRUCT_DESC: 24-inch corrugated metal drainpipe through the levee 13.5 feet below the crown. Slide gate in corrugated metal pipe riser on waterward slope. (ABO No. 9530 - Halsey). O&M manual 136, revision May 2011. FS Date: 04/07/2015

Waterside view: CMP riser with slide gate

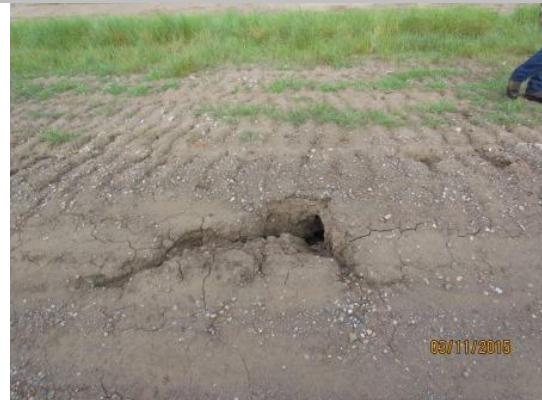
Photo 1 of 1 : FA_2015_ST0003_264_14_20150910_00005.jpg

LM Start	6.78	Rating **	U	Issue No.	14
LM End	6.78	Issue Type +	Ma	Location *	WS
Category	Earthen Levee			GPS Latitude/Longitude	
				Start	End
Item	Erosion / Bank Caving			39.228535 °	39.228535 °
				-121.998330 °	-121.998330 °
DWR ID	DWR_ST0003_01_s_2015_14				
Action/Comments					
Schedule repair of erosion site prior to the next inspection. Inspector Comments: The erosion along the waterside slope needs to be repaired.

View of the erosion along the waterside slope.

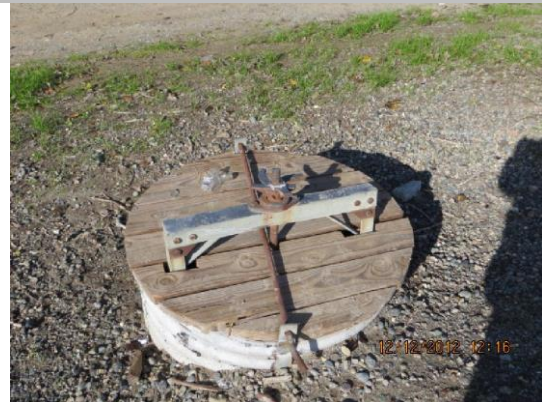
Photo 1 of 2 : UCIP_FA_2015_2899.jpg

Action/Comments					
Inspector Comments: FS_ID:44224 DS_ID:17300 EP_NO: N/A FS_HLM: 7.58 Repair Type: Non-Urgent Crossing Status: Found UCIP Comments: 4/1/2015 Only cmp riser and slide gate found on WS. Abandoned riser with slide gate on WS. Abandoned concrete surge box on WS. Verify pipe has been abandoned properly. 7/23/2013 Same as last inspection. 12/18/2013 Same as last inspection. 6/30/2014 Same as last inspection. FIELD_STRUCT_DESC: Abandoned 24-inch corrugated metal drainpipe through the levee 14.5 feet below the crown. Slide gate in concrete surge box on berm. Slide gate in corrugated metal pipe riser and pump on the waterward slope. O&M manual 136, revision May 2011. FS Date: 04/07/2015

Waterside view: CMP riser with slide gate

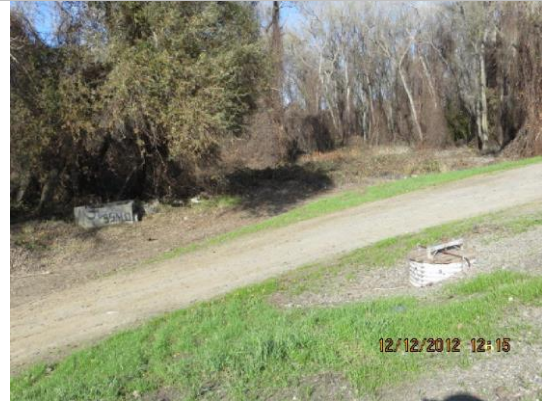
Photo 2 of 2 : UCIP_FA_2015_2900.jpg

Item	DWR UCIP Field Study			39.238153 °	39.238153 °	
				-121.995024 °	-121.995024 °	
DWR ID						
Action/Comments						
Inspector Comments: FS_ID:44224 DS_ID:17300 EP_NO: N/A FS_HLM: 7.58 Repair Type: Non-Urgent Crossing Status: Found UCIP Comments: 4/1/2015 Only cmp riser and slide gate found on WS. Abandoned riser with slide gate on WS. Abandoned concrete surge box on WS. Verify pipe has been abandoned properly. 7/23/2013 Same as last inspection. 12/18/2013 Same as last inspection. 6/30/2014 Same as last inspection. FIELD_STRUCT_DESC: Abandoned 24-inch corrugated metal drainpipe through the levee 14.5 feet below the crown. Slide gate in concrete surge box on berm. Slide gate in corrugated metal pipe riser and pump on the waterward slope. O&M manual 136, revision May 2011. FS Date: 04/07/2015

Waterside view: overview

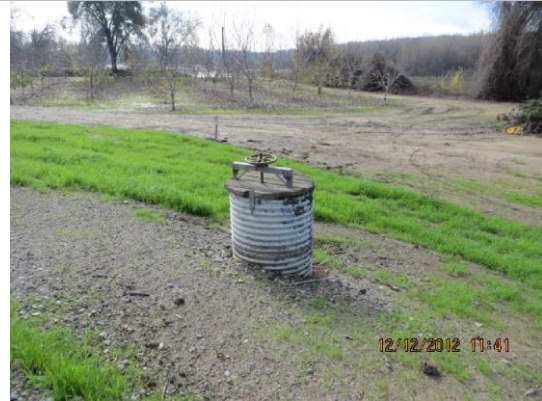
Photo 1 of 3 : UCIP_FA_2015_2685.jpg

LM Start	8.32	Rating **	M	Issue No.	157
LM End	8.32	Issue Type +	En	Location *	WS
Category	Supplemental			GPS Latitude/Longitude	
				Start	End
Item	DWR UCIP Field Study			39.246317 °	39.246317 °
				-121.998825 °	-121.998825 °
DWR ID					
Action/Comments					
Inspector Comments: FS_ID:44229 DS_ID:17304 EP_NO: 9529 FS_HLM: 8.323 Repair Type: Non-Urgent Crossing Status: Found UCIP Comments: 4/1/2015 CMP riser and slidegate on WS. LS distribution box is silted in. Looks abandoned. CMP riser with slide gate on WS. Concrete distribution box on LS- full with silt. 7/23/2013 Same as last inspection. 12/18/2013 Same as last inspection. 6/30/2014 Same as last inspection. FIELD_STRUCT_DESC: 24-inch corrugated metal pipe through the levee, slide gate CMP riser on the waterward slope. Concrete box at the landward toe. Pipe invert 12.8 ft below crown. (ABO No. 9529 - Dorwood Ranch) O&M manual 136, revision May 2011. FS Date: 04/07/2015

Waterside view: overview of CMP riser

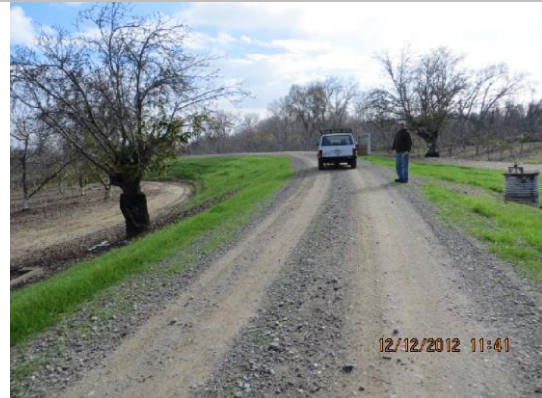
Photo 2 of 3 : UCIP_FA_2015_2686.jpg

Crown view: overview (both sides of the levee)

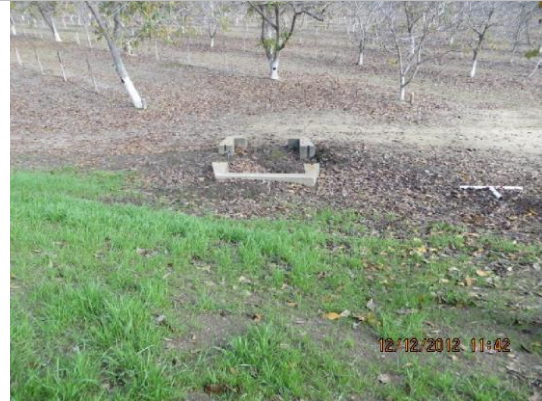
Photo 3 of 3 : UCIP_FA_2015_2913.jpg

LM Start	8.32	Rating **	M	Issue No.	157 (cont)
LM End	8.32	Issue Type +	En	Location *	WS
Category	Supplemental			GPS Latitude/Longitude	
				Start	End
Item	DWR UCIP Field Study			39.246317 °	39.246317 °
				-121.998825 °	-121.998825 °
DWR ID					
Action/Comments					
Inspector Comments: FS_ID:44229					
DS_ID:17304					
EP_NO: 9529					
FS_HLM: 8.323					
Repair Type: Non-Urgent					
Crossing Status: Found

Landside view: overview of concrete box

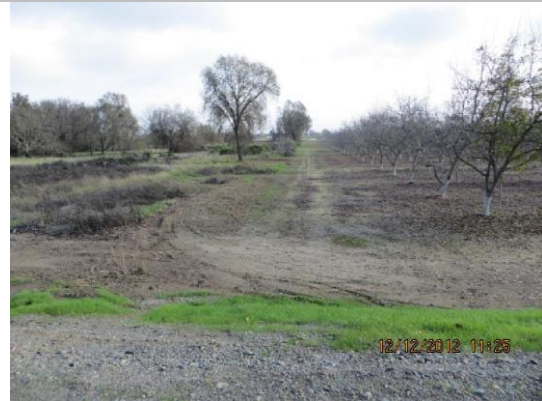
Photo 1 of 3 : UCIP_FA_2015_2687.jpg

LM Start	8.52	Rating **	U	Issue No.	158
LM End	8.52	Issue Type +	En	Location *	WS
Category	Supplemental			GPS Latitude/Longitude	
				Start	End
Item	DWR UCIP Field Study			39.249125 °	39.249125 °
				-121.999031 °	-121.999031 °
DWR ID					
Action/Comments					
Inspector Comments: FS_ID:44243 DS_ID:17295 EP_NO: N/A FS_HLM: 8.519 Repair Type: Urgent Crossing Status: Found UCIP Comments: 4/1/2015 Both WS and LS pipe ends have been dug up in preparation for an internal camera inspection. Pipe shows signs of heavy rust and both ends of pipe are plugged with soil.Only a CMP riser with slide gate found on WS.7/23/2013 Same as last inspection.12/18/2013 Same as last inspection.6/30/2014 Same as last inspection. FIELD_STRUCT_DESC: Abandoned 24-inch irrigation and drain pipe through the levee. Slide gate in corrugated metal pipe riser on the waterward slope. Pipe invert 11.50 ft below the crown. O&M manual 136, revision May 2011. FS Date: 04/07/2015

Landside view: overview (no pipes)

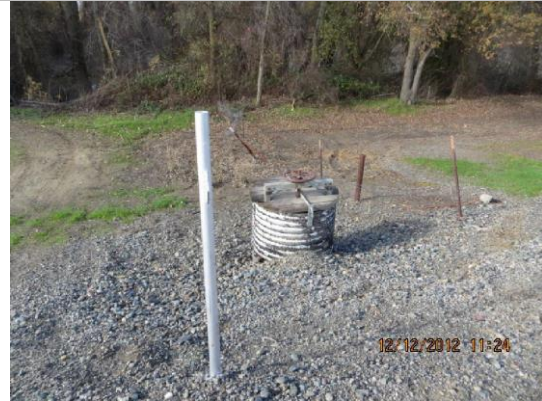
Photo 2 of 3 : UCIP_FA_2015_2688.jpg

Item	DWR UCIP Field Study			39.249125 °	39.249125 °	
				-121.999031 °	-121.999031 °	
DWR ID						
Action/Comments						
Inspector Comments: FS_ID:44243 DS_ID:17295 EP_NO: N/A FS_HLM: 8.519 Repair Type: Urgent Crossing Status: Found UCIP Comments: 4/1/2015 Both WS and LS pipe ends have been dug up in preparation for an internal camera inspection. Pipe shows signs of heavy rust and both ends of pipe are plugged with soil.Only a CMP riser with slide gate found on WS.7/23/2013 Same as last inspection.12/18/2013 Same as last inspection.6/30/2014 Same as last inspection. FIELD_STRUCT_DESC: Abandoned 24-inch irrigation and drain pipe through the levee. Slide gate in corrugated metal pipe riser on the waterward slope. Pipe invert 11.50 ft below the crown. O&M manual 136, revision May 2011. FS Date: 04/07/2015

Waterside view: overview of CMP riser

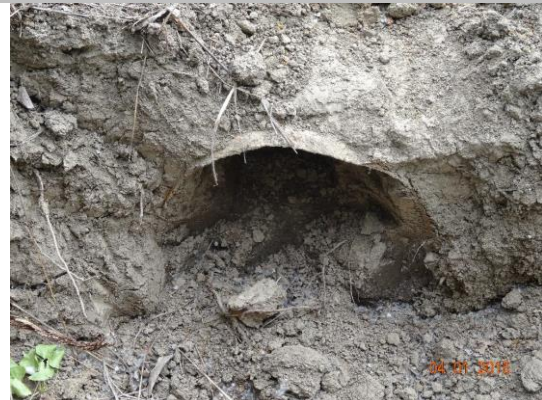
Photo 3 of 3 : UCIP_FA_2015_4748.jpg

WS pipe end

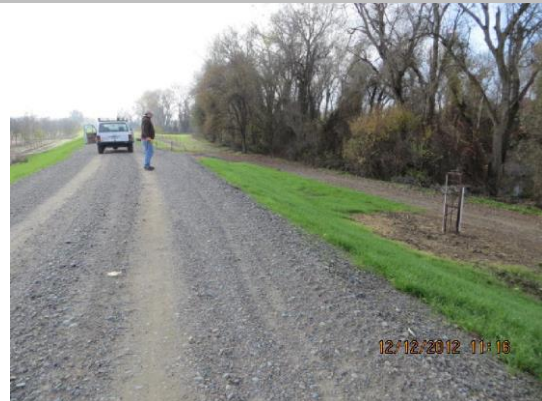
Photo 2 of 3 : UCIP_FA_2015_2690.jpg

LM Start	8.56	Rating **	M	Issue No.	159
LM End	8.56	Issue Type +	En	Location *	WS
Category	Supplemental			GPS Latitude/Longitude	
				Start	End
Item	DWR UCIP Field Study			39.249678 °	39.249678 °
				-121.999021 °	-121.999021 °
DWR ID					
Action/Comments					
Inspector Comments: FS_ID:44245					
DS_ID:17327					
EP_NO: N/A					
FS_HLM: 8.557					
Repair Type: Non-Urgent					
Crossing Status: Found

Waterside view: overview

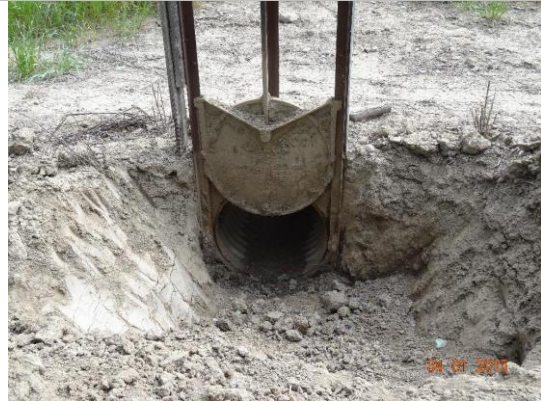
Photo 3 of 3 : UCIP_FA_2015_4414.jpg

LM Start	8.56	Rating **	M	Issue No.	159 (cont)
LM End	8.56	Issue Type +	En	Location *	WS
Category	Supplemental			GPS Latitude/Longitude	
				Start	End
Item	DWR UCIP Field Study			39.249678 °	39.249678 °
				-121.999021 °	-121.999021 °
DWR ID					
Action/Comments					
Inspector Comments: FS_ID:44245 DS_ID:17327 EP_NO: N/A FS_HLM: 8.557 Repair Type: Non-Urgent Crossing Status: Found

WS pipe end

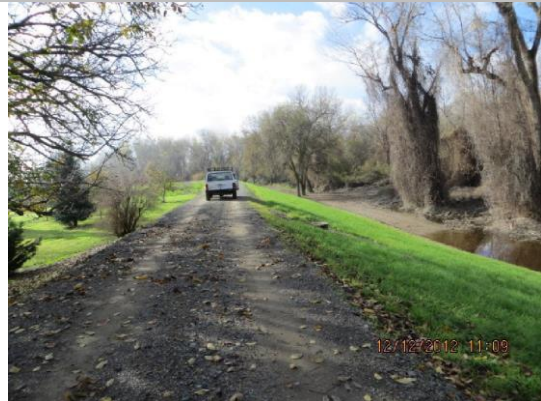
Photo 1 of 3 : UCIP_FA_2015_6017.jpg

LM Start	8.70	Rating **	U	Issue No.	160
LM End	8.70	Issue Type +	En	Location *	WS
Category	Supplemental			GPS Latitude/Longitude	
				Start	End
Item	DWR UCIP Field Study			39.251504 °	39.251504
				-121.997879 °	-121.997879
DWR ID					
Action/Comments					
Inspector Comments: FS_ID:46580 DS_ID:17352 EP_NO: 9523 FS_HLM: 8.7 Repair Type: Urgent Crossing Status: Found UCIP Comments: 8/28/2015 Pipe has been dug up and located along the WS levee toe. 7/23/2013 Same as last inspection. Unable to locate.12/18/2013 Unable to locate6/30/2014 Unable to locate. FIELD_STRUCT_DESC: 10-inch concrete encased steel pipe through the levee, gate valve in 42-inch corrugated metal pipe riser on the waterward slope. (ABO No. 9523 - Blackmore). Pipe invert 15.0 ft below crown. O&M manual 136, revision May 2011. FS Date: 07/08/2014

view from crown of levee

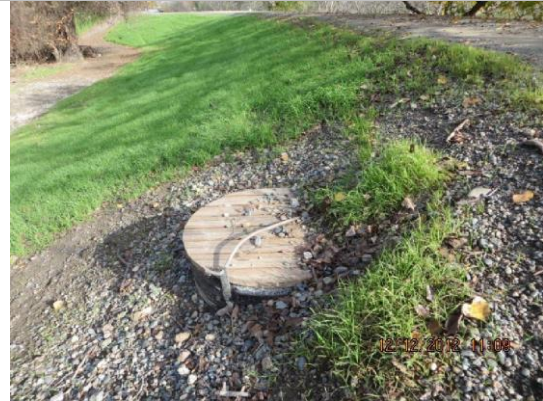
Photo 2 of 3 : UCIP_FA_2015_6018.jpg

Inspector Comments: FS_ID:46580
 DS_ID:17352
 EP_NO: 9523
 FS_HLM: 8.7
 Repair Type: Urgent
 Crossing Status: Found
 UCIP Comments: 8/28/2015 Pipe has been dug up and located along the WS levee toe. 7/23/2013 Same as last inspection. Unable to locate. 12/18/2013 Unable to locate 6/30/2014 Unable to locate.
 FIELD_STRUCT_DESC: 10-inch concrete encased steel pipe through the levee, gate valve in 42-inch corrugated metal pipe riser on the waterward slope. (ABO No. 9523 - Blackmore).
 Pipe invert 15.0 ft below crown.
 O&M manual 136, revision May 2011.
 FS Date: 07/08/2014

42inch riser on WS shoulder

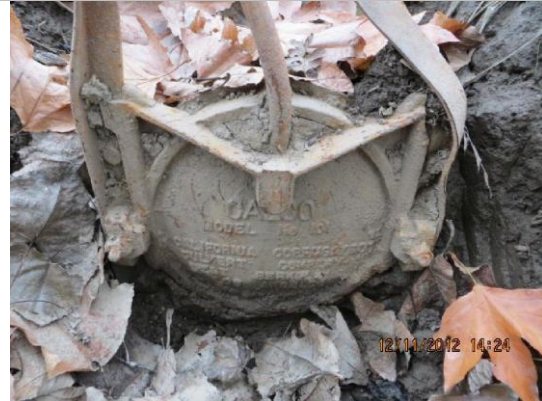
Photo 1 of 3 : UCIP_FA_2015_2691.jpg

LM Start	8.75	Rating **	U	Issue No.	161
LM End	8.75	Issue Type +	En	Location *	WS
Category	Supplemental			GPS Latitude/Longitude	
				Start	End
Item	DWR UCIP Field Study			39.252121 °	39.252121 °
				-121.997740 °	-121.997740 °
DWR ID					
Action/Comments					
Inspector Comments: FS_ID:46581					
DS_ID:17353					
EP_NO: N/A					
FS_HLM: 8.743					
Repair Type: Urgent					
Crossing Status: Indicator Found

Waterside view: close view of slide gate

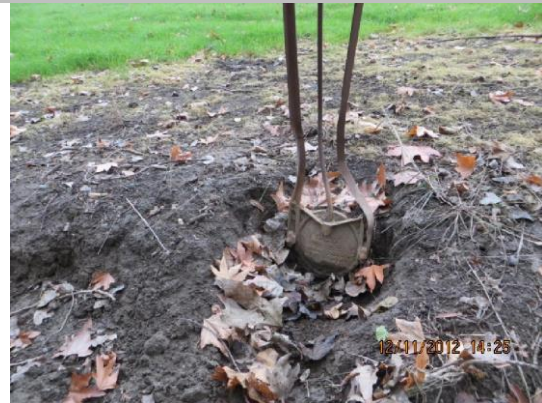
Photo 2 of 3 : UCIP_FA_2015_2692.jpg

Waterside view: slide gate on steel structure

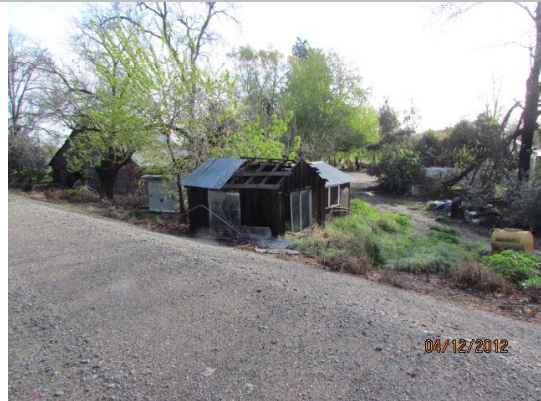
Photo 1 of 1 : FA_2015_ST0003_264_2_20150910_00001.jpg

LM Start	8.75	Rating **	U	Issue No.	2
LM End	8.75	Issue Type +	En	Location *	LS
Category	Earthen Levee			GPS Latitude/Longitude	
				Start	End
Item	Encroachments			39.252260 °	39.252260 °
				-121.997721 °	-121.997721 °
DWR ID	DWR_ST0003_01_s_2012_2				
Action/Comments					
Building

View of the building next to the toe of the levee.

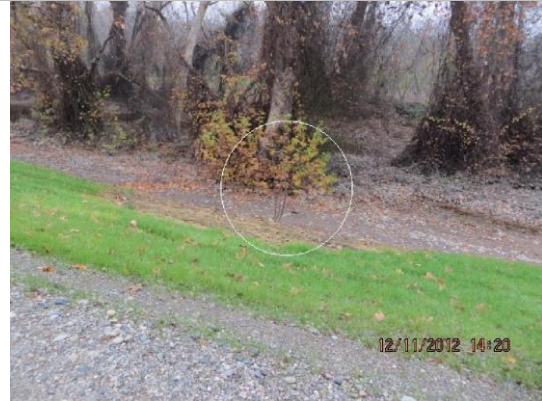
Photo 1 of 3 : UCIP_FA_2015_6086.jpg

Inspector Comments: FS_ID:46582
DS_ID:17354
EP_NO: N/A
FS_HLM: 8.78
Repair Type: Non-Urgent
Crossing Status: Found
UCIP Comments: 8/28/2015 Pipe files was mixed up with the pipe at LM8.743. Pipe is abandoned with a damaged crew gate on the WS toe of levee. 7/23/2013 Same as last inspection. Unable to locate. 12/18/2013 Unable to locate. 6/30/2014 Unable to locate.
FIELD_STRUCT_DESC: 12-inch corrugated metal drainpipe through the levee, slide gate on the waterward end.
Pipe invert 12.50 ft below crown.
O&M manual 136, revision May 2011.
FS Date: 08/28/2015

WS view from top of crown
